## RAND

## **Historic Restoration**

## 901 Broadway

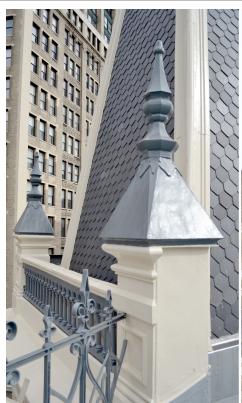
The original slate shingles on the mansard roof were reinstalled wherever possible. The finials (left) were restored, or replaced where missing with fiberglass replicas, and a large structural crack in the pavilion was repaired (center). Decorative cast iron facade elements, such as column and pilaster capitals (right), were also restored to their original beauty.

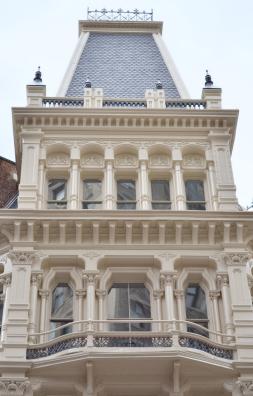
Now part of the Ladies' Mile Historic District, the building was designated a New York City Landmark in 1977, but it continued its steady decline. Many of the original cast iron elements deteriorated beyond repair. The slate mansard roof and gutter were badly water damaged, and a large structural crack had formed in the pavilion.

- Roofing system structurally reinforced to stablize pavilion.
- Interior drain lines installed to eliminate exterior leader pipes.
- Cladding removed from roof level bulkheads and new lead-coated copper cladding installed.
