## RAND

## **Historic Restoration**

## 901 Broadway

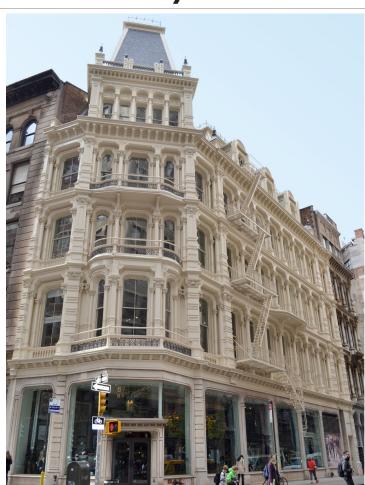
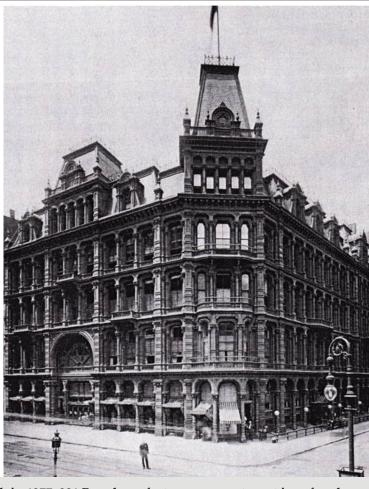
Completed in 1870 and declared a New York City Landmark in 1977, 901 Broadway features an ornate cast iron facade, corner pavilion, and slate mansard roof. The southern portion of the building was demolished in the early 20th century.

Now part of the Ladies' Mile Historic District, the building was designated a New York City Landmark in 1977, but it continued its steady decline. Many of the original cast iron elements deteriorated beyond repair. The slate mansard roof and gutter were badly water damaged, and a large structural crack had formed in the pavilion.

In 2011, **RAND** was engaged to design and administer an extensive exterior restoration program, reviving the building's original architectural and historic glory and setting the stage for its comeback. Brooks Brothers has since opened a concept store on the ground floor and basement, a nod to the building's storied retail history. A residential/work space, two private apartments, and a commercial space exist over the next four floors. The *New York Observer* called 901 Broadway "one of the most architecturally unique buildings still standing in Manhattan."
