# **EMERGENCY PREPAREDNESS**

# **Chiller Replacement and Relocation**

135 Montgomery Street, Jersey City, NJ

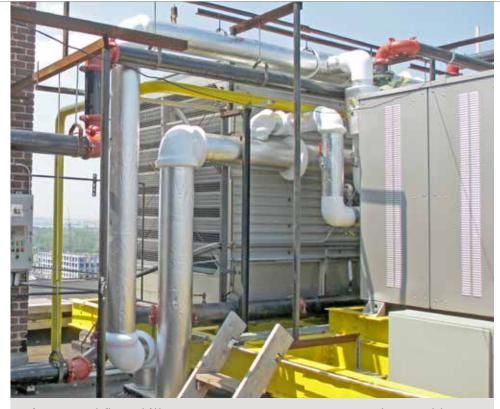
The new double-effect chillers also provide back-up heating in winter.

After ground-floor chillers at 135 Montgomery Street were destroyed by Hurricane Irene in 2011 and then Superstorm Sandy a year later, new replacement chillers were relocated on the roof and placed on a reinforced steel platform.

Given the increased threat of severe future storms, the board decided it wasn't worth the risk of installing new chillers in the same ground-level location as before. Instead, the replacement chillers were installed on the roof. The new "double-effect" chillers RAND specified also provide back-up heating in the winter.

**RAND** conducted a structural feasibility study of an existing steel platform on the roof to assess its ability to support

the new chillers. In addition, repairs were made to the existing boilers, pumps, and electrical equipment.
